Building a GPS Receiver for Space

Lessons Learned

ABSTRACT

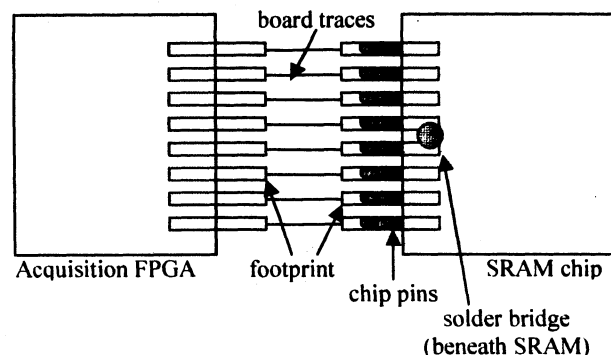
The day that the team performed the initial unit test of the Navigator board, two sets of unrelated pins were failing. Many of the pins were address pins. This was causing data contents to be written in the wrong memory location.

Figure 4: Location of a solder bridge

Upon reading the statistics registers, the test engineer knew to look more closely at the pins of the SRAM. It was discovered that solder had splashed under the body of the SRAM and "bridged" (connected) two unrelated pins. This can be seen in Figure 4. Due to the location of the solder bridge, it was difficult to see unless an inspector knew that it was there. Because of the self testing mechanism, the problem was caught quickly and early in the development process.

If the problem had gone undetected, it would have caused erroneous acquisition results. Because the bridge caused two pins to be shorted together, it would likely have reduced the life span of the Acquisition FPGA which was commanding those pins.

Connectivity errors are fairly common in development systems. It is generally easy to implement circuitry or software to perform basic connectivity tests. They are well worth the investment.

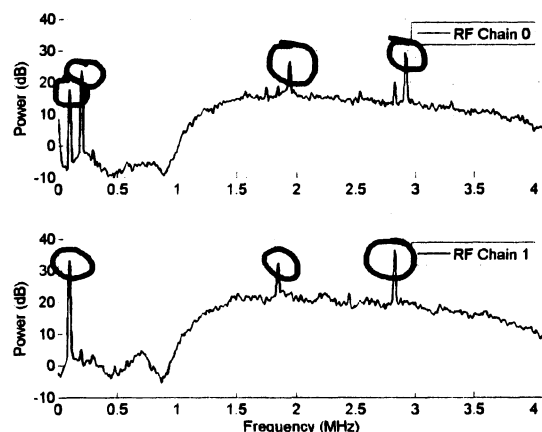
We then ran several tests at 30 dB-Hz and initially were not able to acquire the signals. The first observed symptom was that the forward FFT began overflowing. This made the team think that there was a strong in-band signal that was getting to the ADC.

The RF Daughtercard was reconnected. Digital samples of the I/F signal were taken at the Analog to Digital Converter (ADC) and stored to a file using a digital logic analyzer. When the samples were analyzed, spurs were seen in the power spectral density (PSD) plot. This showed that there was a signal that was getting into the RF or IF chain. Due to the 8.192 MHz sampling, we could only see the aliased frequency of the unwelcome signal.

Figure 5: Location of unwanted spurs on PSD chart.

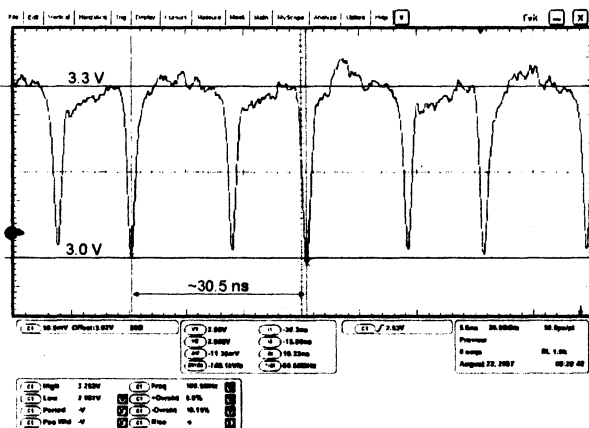
The captured image in Figure 7 shows the voltage on an output pin as a function of time. This signal should be a constant 3.3 volts, however it has recurring spurs that drop down to 2.96 volts. These fast changes create noise.

Figure 7: Voltage Spurs on the ColdFire scan-out pins.

The signal displayed in Figure 7 should be constantly high at 3.3 volts. The clock input to the processor is 65.536 MHz, and gets divided by two inside the processor to create a bus clock of 32.768 MHz. It appears that there are two overlapping sets of spurs, which occur at the slower clock frequency. The spurs last only 1-2 nanoseconds from the beginning of their drop to their return to the nominal 3.3 volts. Each spur seen has a magnitude of approximately 0.3 volts.

The peaks were occurring at a frequency of approximately 65.536 MHz. The team observed the harmonics of this frequency on the spectrum analyzer. The 24th harmonic of this frequency is 1.57286 GHz, and the L1 C/A code signal is located at 1.57542 GHz. The signals are separated by only 2.56 MHz. While the RF filter's pass band was only 2 MHz wide, the cutoff was not sharp enough to attenuate the emitted harmonic. This harmonic affected each of the amplifiers located before the mixer. Once the incoming signal is mixed down to 35.42 MHz, it is no longer susceptible to the aggressor.

Ensure that the outputs of any digital circuit are set to low slew (the slowest transition rate). Also ensure that high speed digital signals are properly terminated. Un-terminated high slew signals produce reflections, and cause noise on power and ground lines.

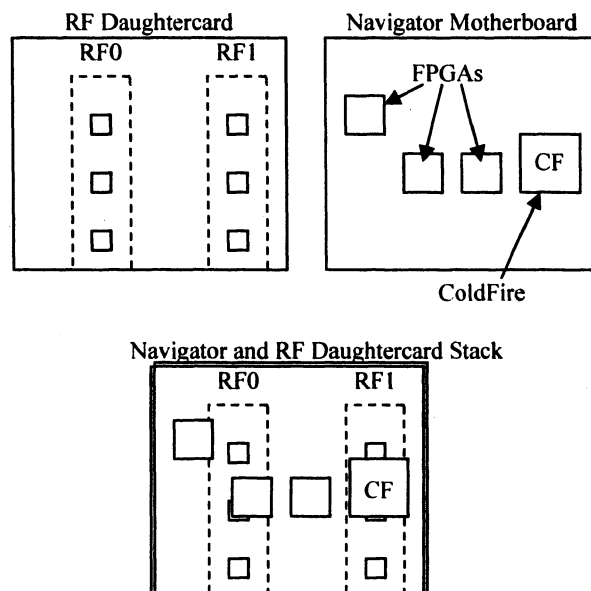
Physical separation also affects the magnitude of interference. As seen Figure 8, only the RF1 chain which was located physically "above" the processor was seriously affected. Even though RF0 was located above several FPGAs, it was only slightly affected by the interference.

Figure 8: Diagram of relative location of components.

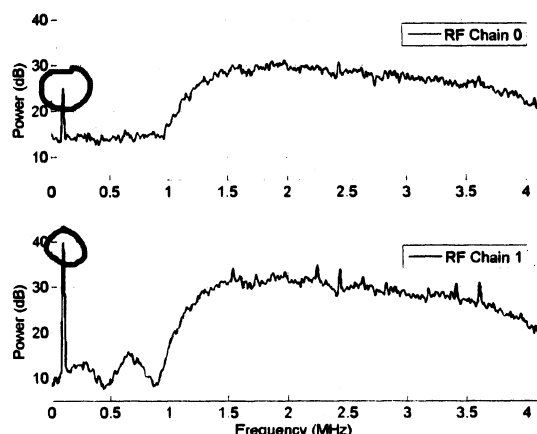
Figure 9: Location of mitigated spurs in PSD chart.

As a result of the mitigation techniques, the LHCP chain (RF Chain 0 - which performs weak signal acquisition) no longer had any spurs above or in the pass band centered at 2.652 MHz. Only one spur was located below the noise floor, but it did not degrade the weak signal acquisition. The RHCP chain (RF Chain 1) still had one spur above the noise floor. Because that chain was only performing fast acquisition, its performance also was not degraded.

Although there was no ready solution to remove the jamming signal, a way had to be found to mitigate the problem. The RF chain had an excess of gain. Each chain had approximately 50 dB of onboard amplification. The rest was off board (located in the antenna's LNA). The gain was needed to implement an Automatic Gain Control (AGC) circuit, which could attenuate any excess gain using digital step attenuators (DSAs). Because each amplifier was allowing the signal to get into the chain, one was removed. This reduced the gain to 37 dB. While

Additionally unshielded passive components on the RF daughtercard were swapped with shielded versions, if available. This improved the magnitude of the jamming frequency, as shown below.

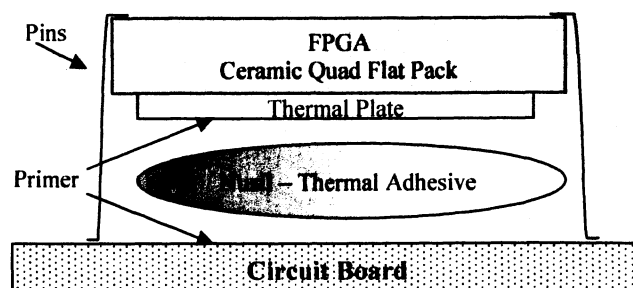
Figure 12: Location of Nusil under FPGA

There are two requirements to achieve this benefit. The first is to place a primer on the bottom of the chip and on the circuit board. Without the primer, the thermal adhesive is not able to stick to anything. The second, sufficient Nusil must be used to cover 80%-90% of the bottom area of the FPGA.

During post-failure analysis, it was discovered that primer was not placed on the FPGA or the board. Secondly, Nusil only covered 40% of the area under the part. Upon further analysis, it was discovered that there was not enough documentation. A technician who was not familiar with the process of using primer in these situation assembled the board. Finally, due to accelerated schedules, the Board left the lab with only a minor inspection.

Don't let aggressive schedules cause your team to overlook details. Ensure that any special procedures are well documented. Engineers who are familiar with techniques have tendencies to forget details. Documentation is even more important, when involving engineers who are unfamiliar with the processes.

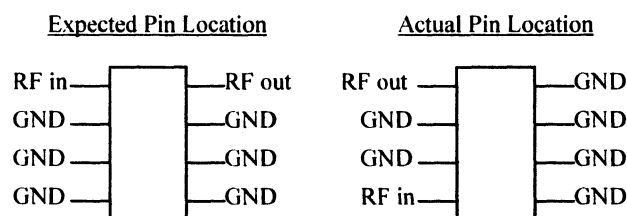
During his testing, he was measuring an unplaced amplifier. This amplifier, which was not on the board, also measured a short between its power pin and its ground pin. Initially, he believed that it was a bad part. After measuring three identical parts, he realized that all had the same internal short. He then unsoldered this family of parts from the RF Daughtercard. There was no longer a short on the board.

Of the eight pins on the amplifier, the Power (which is also RF-Out), the RF-In and the ground pins were at locations other than what was described in the datasheet.

Figure 13: Pin locations of the supplied amplifier.

After verifying the correct pin location, the team needed to refabricate the printed circuit board with the correct footprint of the amplifier.
